PIERCE COUNTY BUILDING COMMITTEE MEETING AGENDA Tuesday, April 16, 2019 – 9:45 a.m. Courthouse - County Board Room; 414 W. Main St. – Ellsworth, WI

RENODRY USA - RISING DAMP REPORT

Pierce County Courthouse

3/15 2019 Rising Damp Report

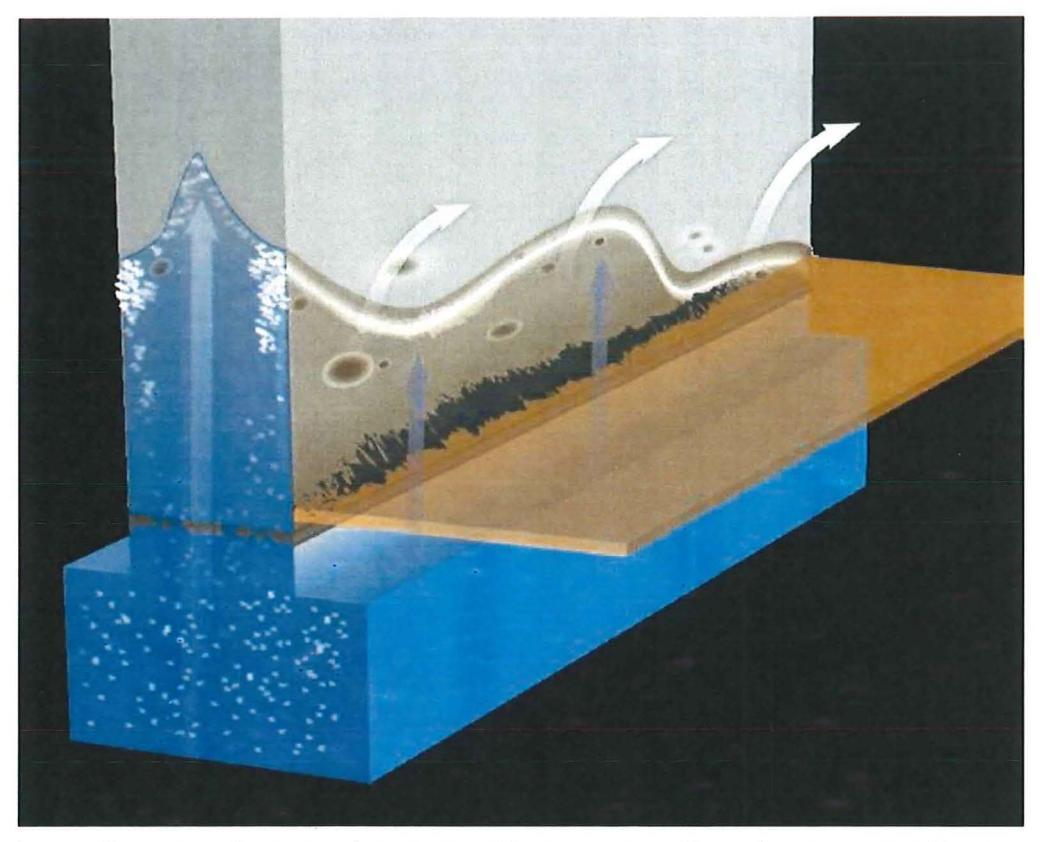
THE FOLLOWING DIAGRAM OF A WALL CROSS-SECTION ILLUSTRATES SEVERAL EROSION INDICATORS IN THE PRESENCE OF RISING DAMP (THE DAMPNESS AND SALTS THAT MOVE UPWARDS INSIDE THE WALL, FROM THE FOUNDATION, AFFECTING THE CORE OF THE MASONRY).

RISING DAMP IS A COMBINED PROBLEM OF DAMPNESS AND SALTS AFFECTING THE MASONRY AT DEPTH.

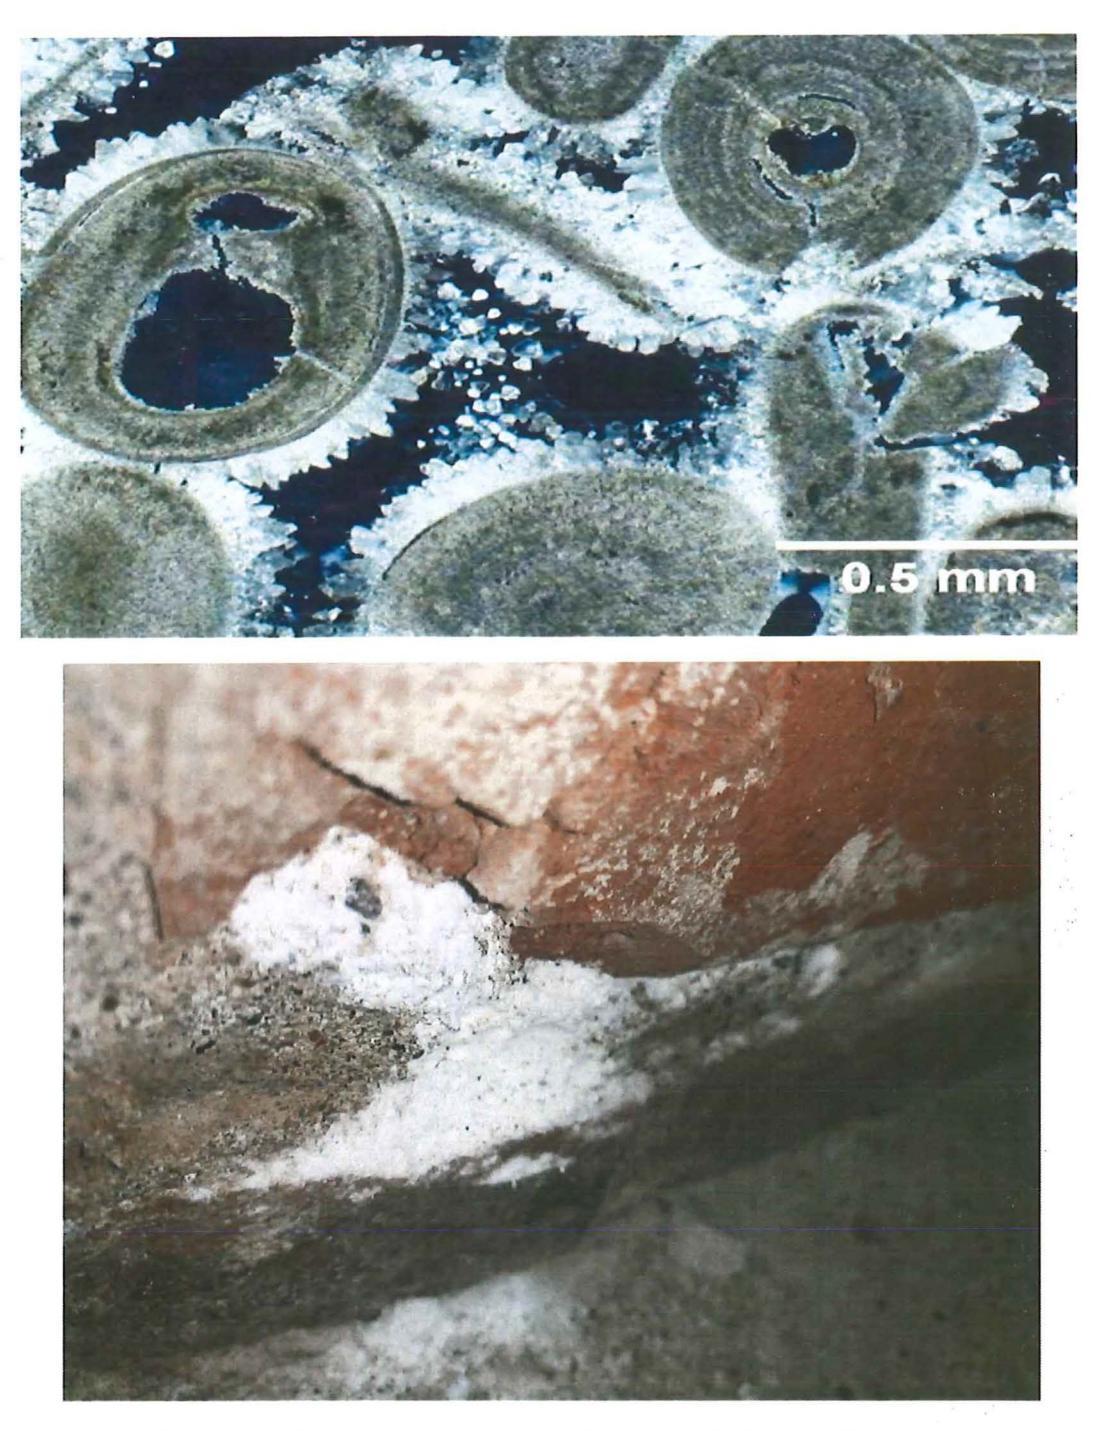
Changes in temperature and/or humidity cause **salt crystals to expand multiple times** within the capillary pores, which generate enough crystallization pressure – up to 2 tons per cm2 - to **crack** the fine pores, irreversibly destroying the masonry. Powdering, flaking, crumbling, delamination or cracking of masonry surfaces are typical signs of a salt attack.

SALT DAMAGE: SALT NEST PUSHING THROUGH WALL IN COURTHOUSE

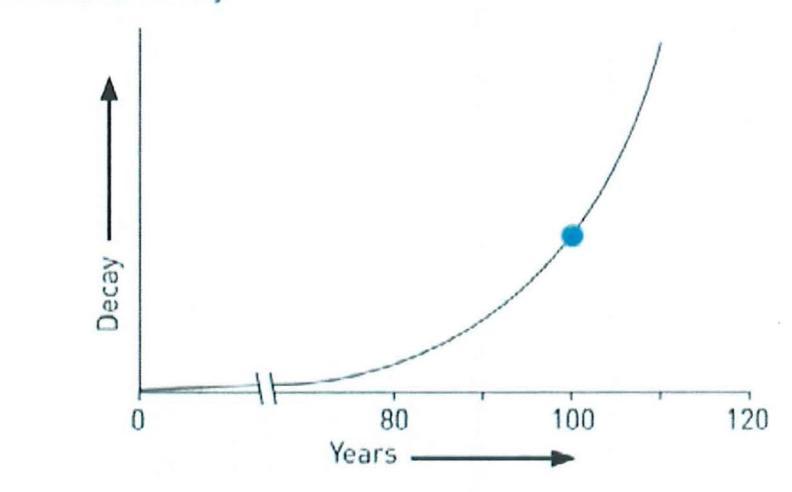
There is a long initial period with almost no decay (80 years in this example) during which time salts slowly accumulate within the masonry pore structure until they reach a saturation point.

After this the **salt decay becomes accelerated**, the volume of decay over the next 10 years will be **twice as destructive** as it is has been.

Rate of salt attack decay

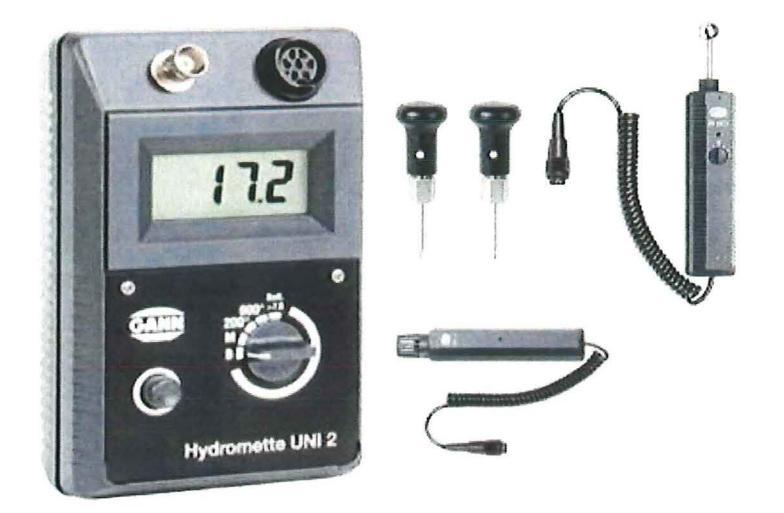
GANN HYDROMETER B50 UNI 2

THE FIRST TEST CONDUCTED BY THE RENODRY ENGINEER INVOLVES THE USE OF A GANN HYDROMETER B50 THAT MEASURES WALL CONDUCTIVITY (THE DEGREE TO WHICH A SPECIFIED MATERIAL CONDUCTS ELECTRICITY). A PROBE IS SET ON THE SURFACE OF THE STONE, MASONRY OR MORTAR AND GIVES A READING INDICATING THE PRESENCE OR ABSENCE OF MOISTURE. THE HIGHER THE READING, THE MORE MOISTURE IS LIKELY IN THE WALL. THIS TEST GIVES THE ENGINEER A STRONG INDICATION THAT THERE IS MOISTURE PRESENT IN THE WALLS.

READINGS ON THE GANN INSTRUMENT RANGE FROM 0, AN INDICATION OF NO MOISTURE, TO 200 THE EQUIVALENT OF TOTAL SATURATION. FOR PURPOSES OF REVEALING MASONRY WALL MOISTURE, READINGS LESS THAN 70 INDICATE NORMAL TO SLIGHTLY ABOVE NORMAL LEVELS OF MOISTURE PRESENT; READINGS ABOVE 70 DEMONSTRATE EXCESSIVE LEVELS OF MOISTURE; **READINGS IN EXCESS OF 100 INDICATE EXTREME MOISTURE LEVELS IN THE MASONRY.** AS A COMPARISON, THE HUMAN BODY, ON AVERAGE WILL READ AROUND 160.

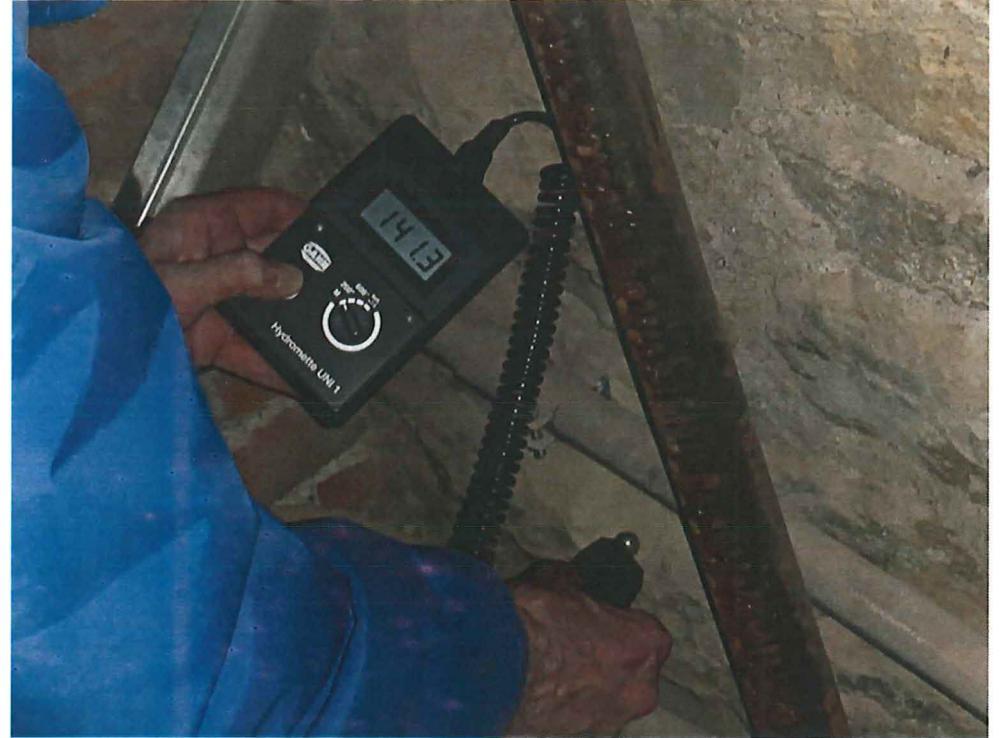
GANN HYDROMETER B50 UNI 2

WATER SATURATED MASONRY: MOISTURE LEVEL IN LOWER FOUNDATION WALL REACHING 141.3 – ALMOST HUMAN BODY LEVELS OF MOISTURE

THE MASONRY WALLS OF PIERCE COUNTY COURTHOUSE HAVE MOISTURE TRAPPED IN THE INNER WALLS. RENODRY'S PRELIMINARY TESTS WITH THE GANN HYDROMETER INDICATED MANY OF THE EXTERIOR AND INTERIOR WALLS THAT COULD BE ACCESSED, HAD READINGS WELL OVER 100 SHOWING THE WALLS ARE BEING ERODED BY RISING DAMP.

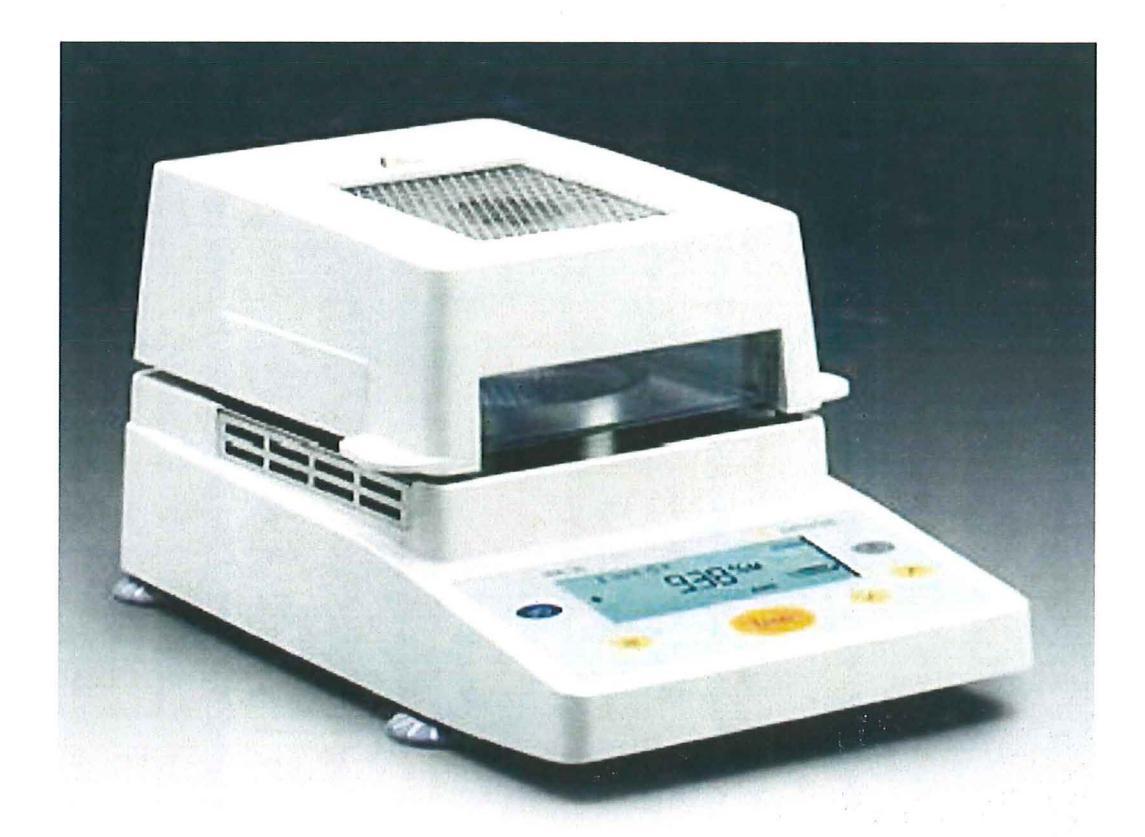
USING THE INTERNATIONAL STANDARD FOR DETERMINING MASONRY WALL MOISTURE – THE GRAVIMETRIC METHOD--RENODRY WILL UTILIZE A SARTORIUS MA35 MOISTURE ANALYZER TO WEIGH EACH MASONRY SAMPLE, DRY IT AT 105 DEGREES C, AND THEN RE-WEIGH THE SAMPLE, THUS DETERMINING THE EXACT WEIGHT % MOISTURE OF THE MASONRY WALLS.

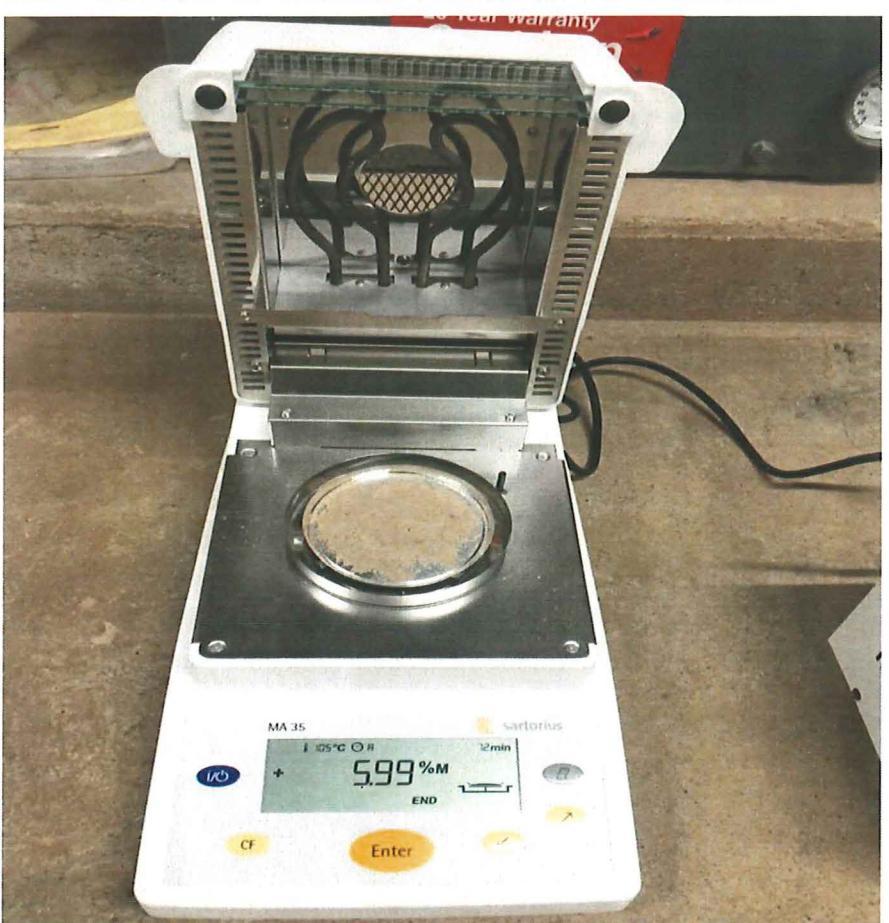
EXAMPLE OF MASONRY CORE SAMPLE BEING WEIGHED, DRIED OUT AND RE-WEIGHED FOR MOISTURE ANALYSIS.

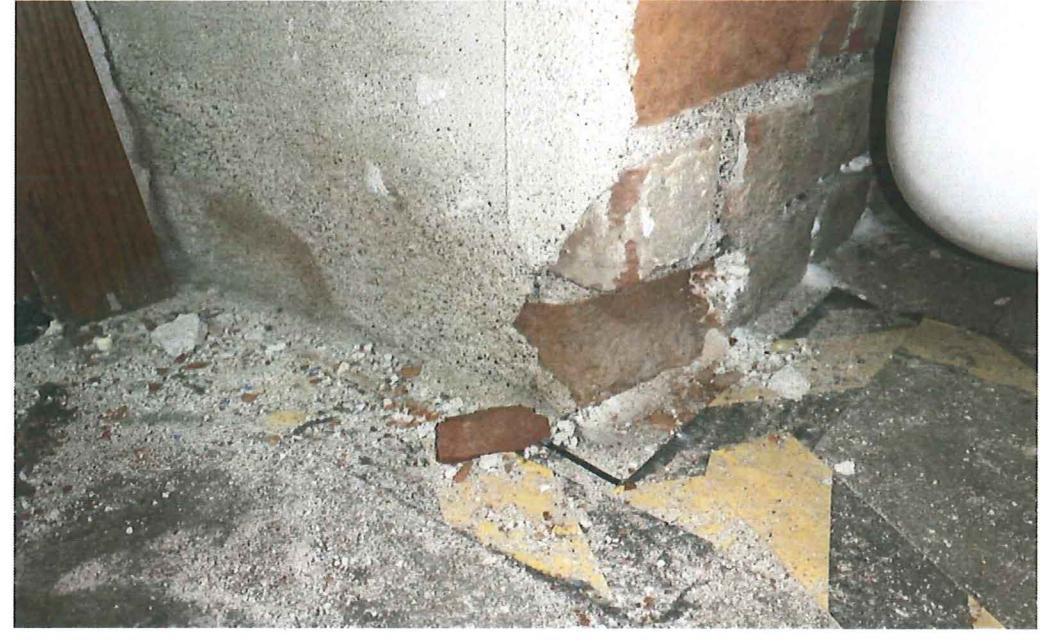
CLEAR EVIDENCE THAT RISING DAMP IS CLIMBING THE MASONRY WALLS. MASONRY EROSION FROM MOISTURE/SALT BEING PUSHED TO THE SURFACE.

A RENODRY DEHYDRATION SYSTEM SHOULD BE INSTALLED IN PIERCE COUNTY COURTHOUSE TO PERMANENTLEY HANDLE THE RISING DAMP PROBLEM AND DRY OUT THE FOUNDATION WALLS.

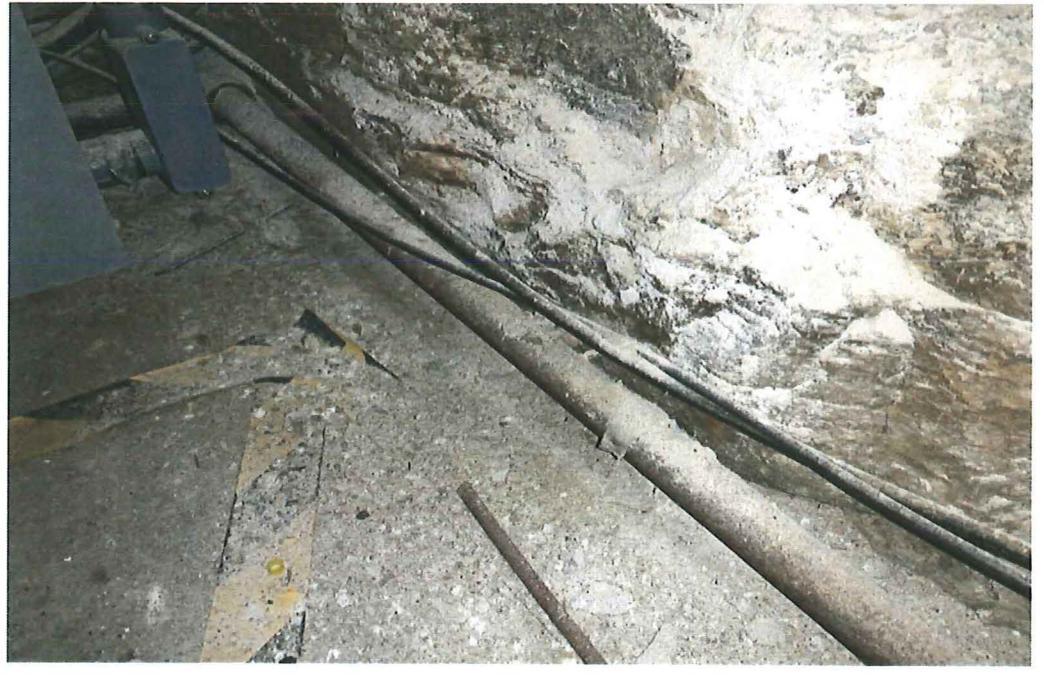
FREE-STANDING INTERIOR WALL WITH LARGE SALT NESTS CRUMBLING THE MORTAR AND STONE. LIMESTONE ERODING FROM ADVANCED RISING DAMP.

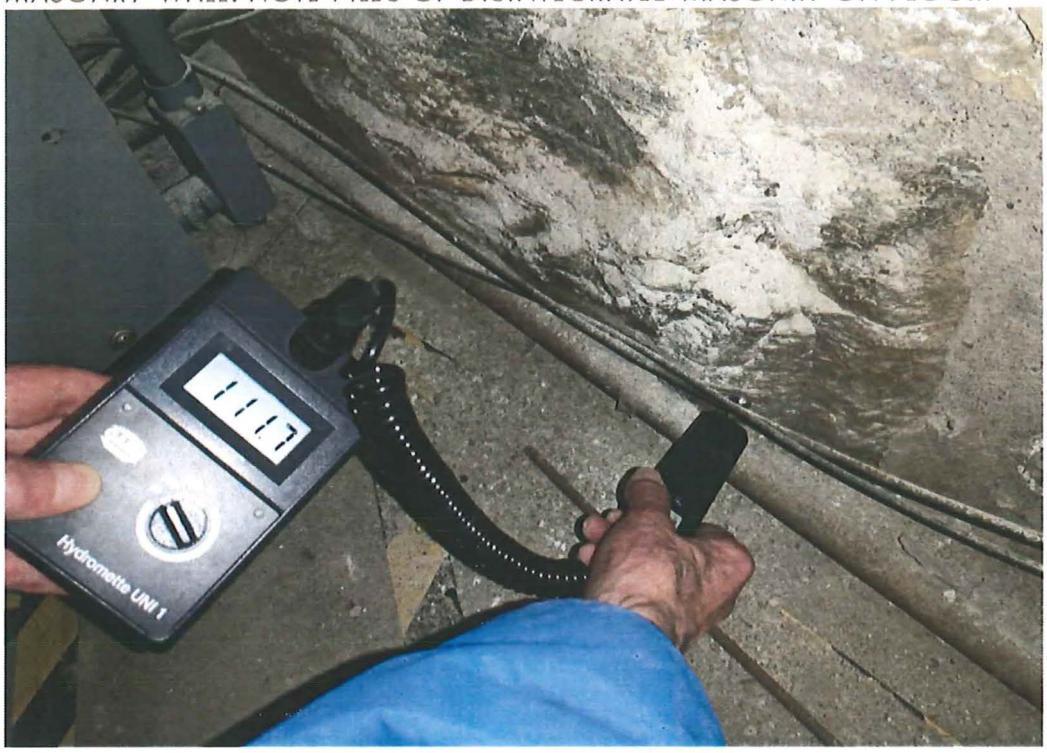
HYDROMETER READINGS OF 111.7 FROM MOISTURE CLIMBING INTERIOR MASONRY WALL. NOTE PILES OF DISINTEGRATED MASONRY ON FLOOR.

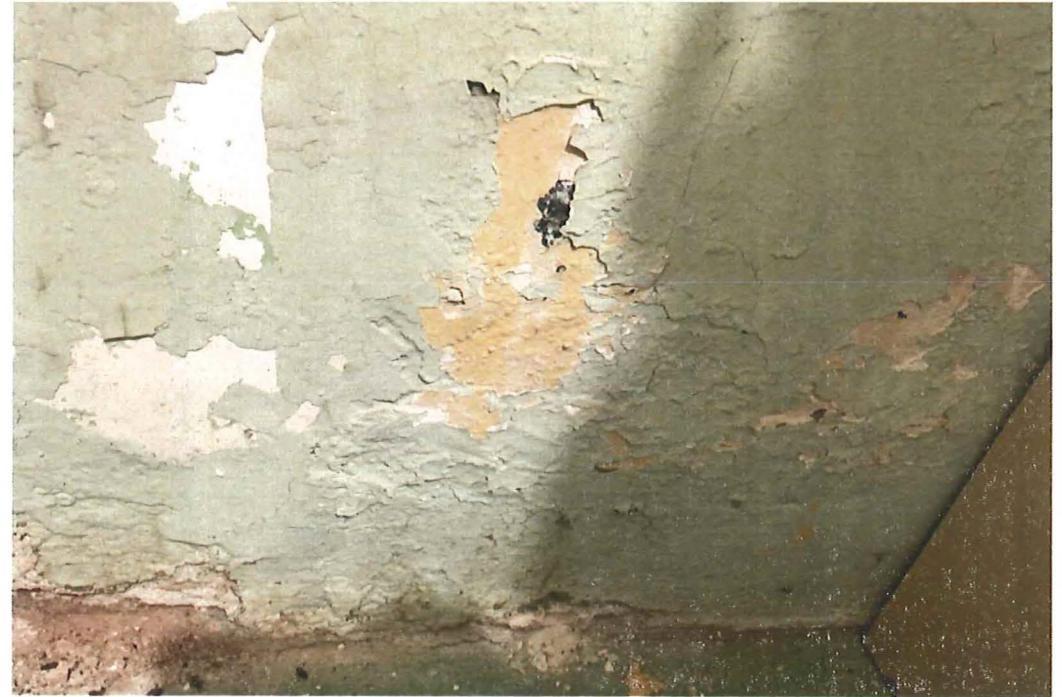
FREE-STANDING MASONRY WALL – SALT NESTS CAUSING PAINT TO PEEL AND PLASTER TO CRUMBLE. PLASTER IS DISINTEGRATING FROM RISING DAMP..

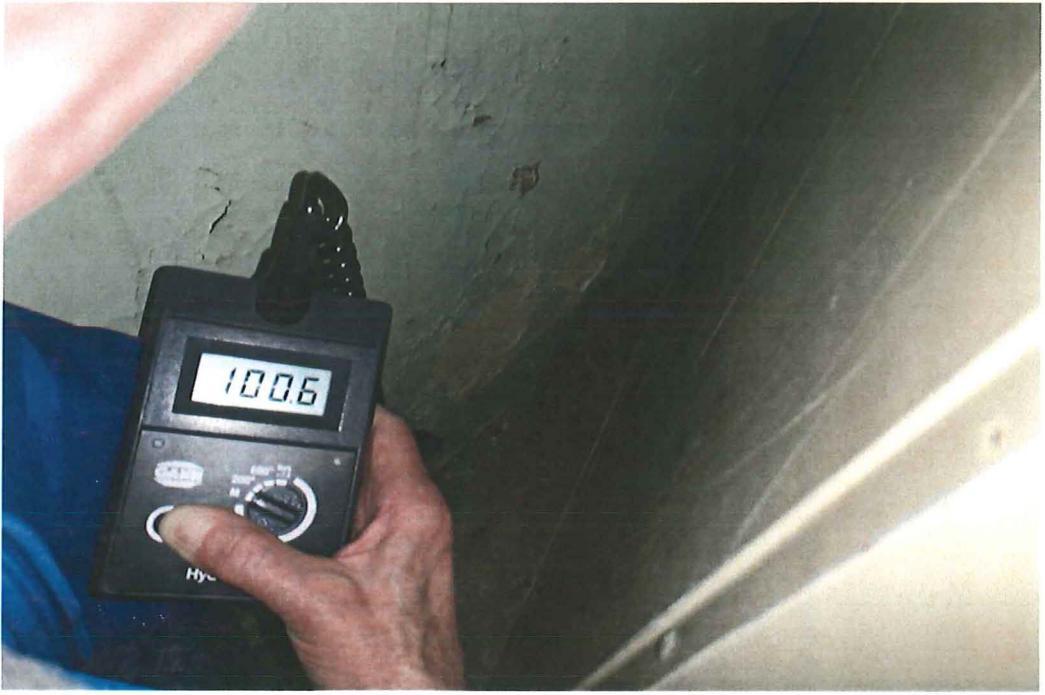
RISING DAMP INDICATED ON FREE-STANDING WALL BY THE EVIDIDENCE OF PEELING PAINT AND DISINTEGRATING PLASTER MOVING UP WALL.

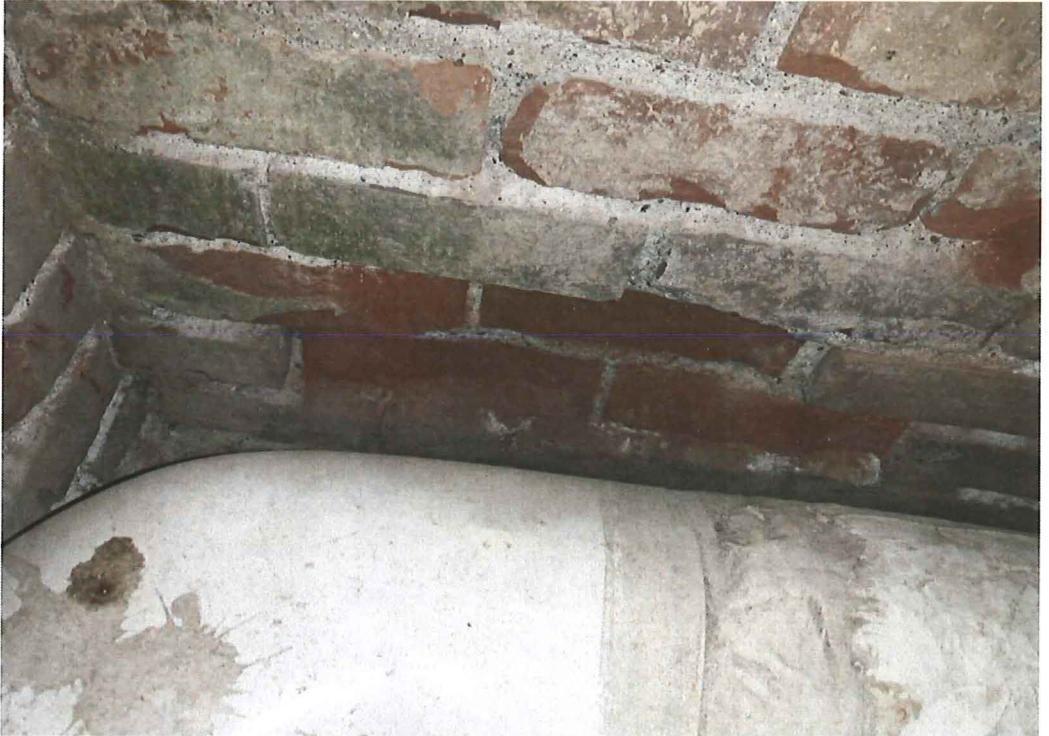
INTERIOR WALL BEING DESTROYED BY RISING DAMP FROM SALTS AND MOISTURE PENETRATION SPALLING THE BRICK FOUNDATION WALL.

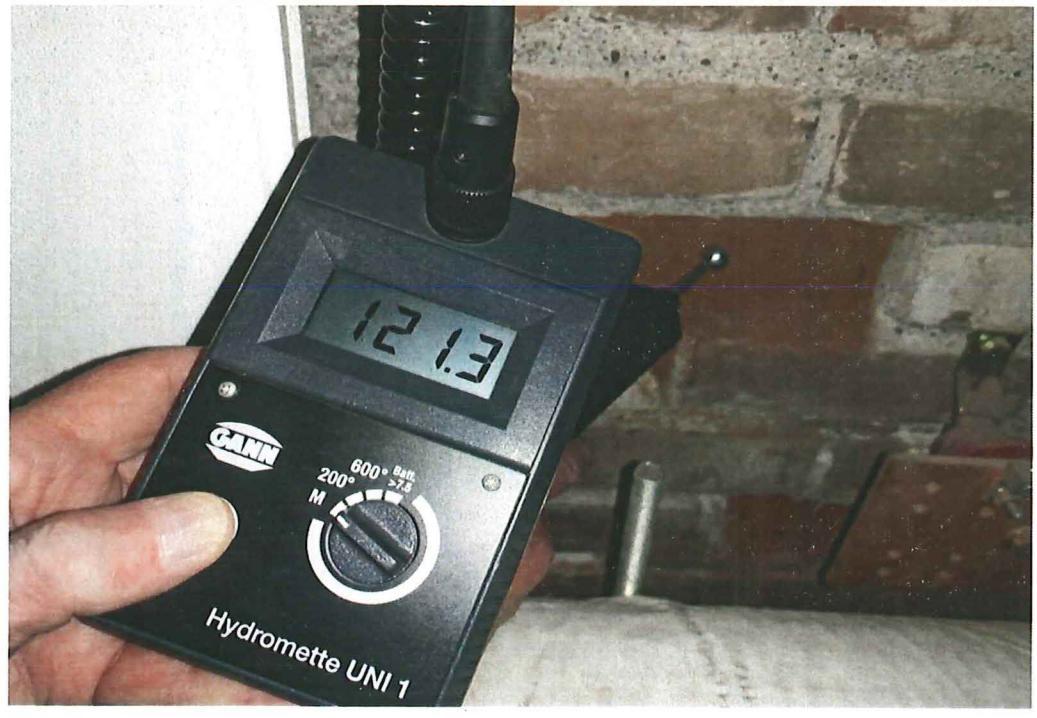
RISING DAMP SHOWING SPALLED BRICK MOISTURE LEVELS AT 121.3. INDICATES SIMILAR CONDITIONS EXIST IN OTHER COVERED WALL AREAS.

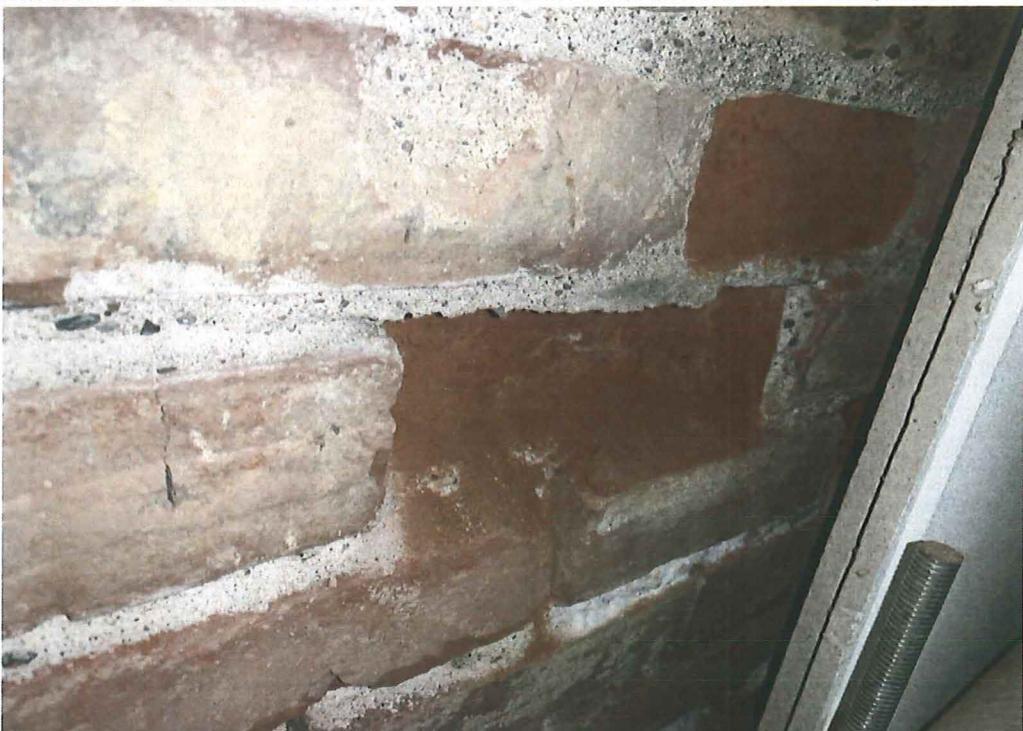
EXCESS SALTS INSIDE BRICK CAPILLARIES RE-CRYSTALLIZING CAUSING BRICKS TO CRUMBLE AND SPALL TO DUST. DESALINIZATION REQUIRED.

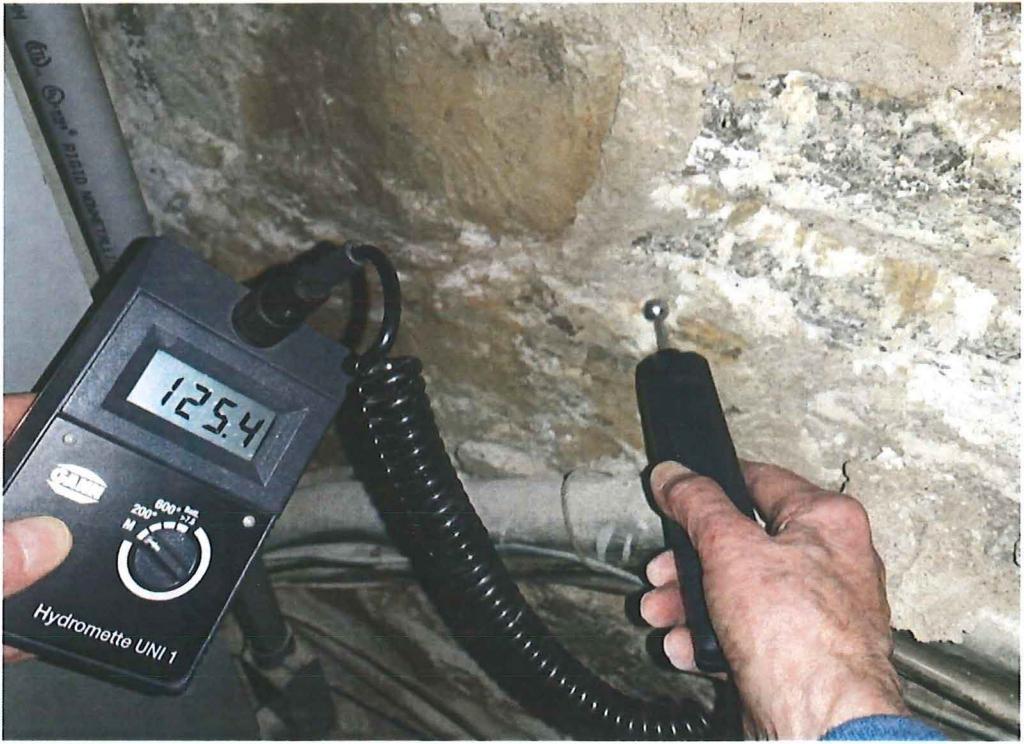
LIMESTONE FREE-STANDING INTERIOR WALL FROM YEARS OF SALTS CORRODING MASONRY NEARLY 3 FEET HIGH UP WALL.

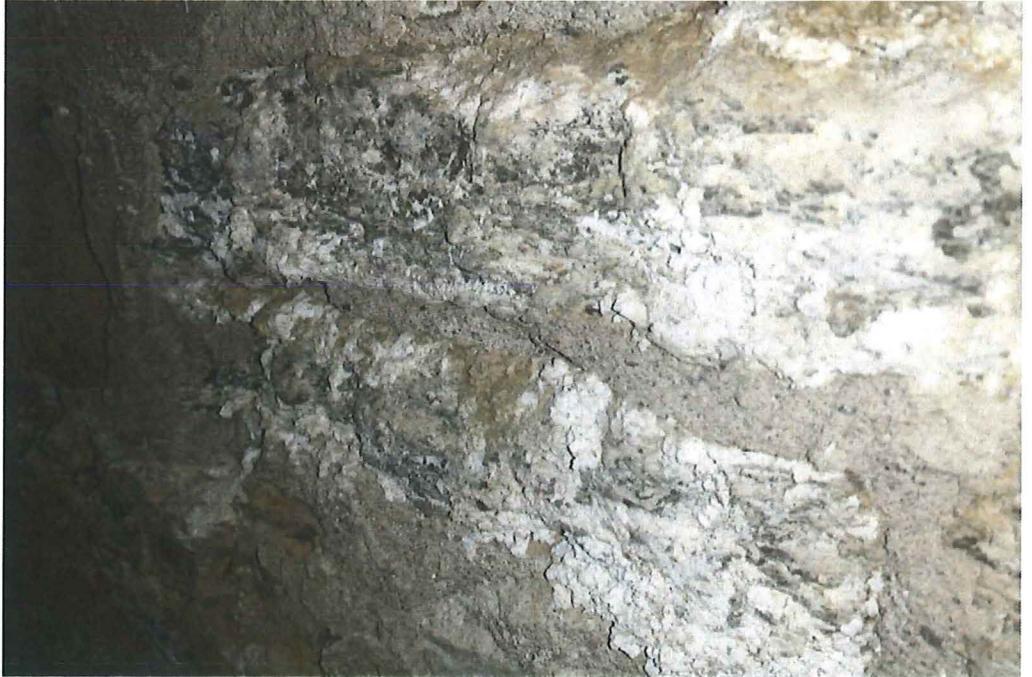
SALTS NESTS ON LIMESTONE WALL SURFACE FROM EXCESSIVE MOISTURE AND SALTS CLIMBING UP WALLS OVER MANY YEARS.

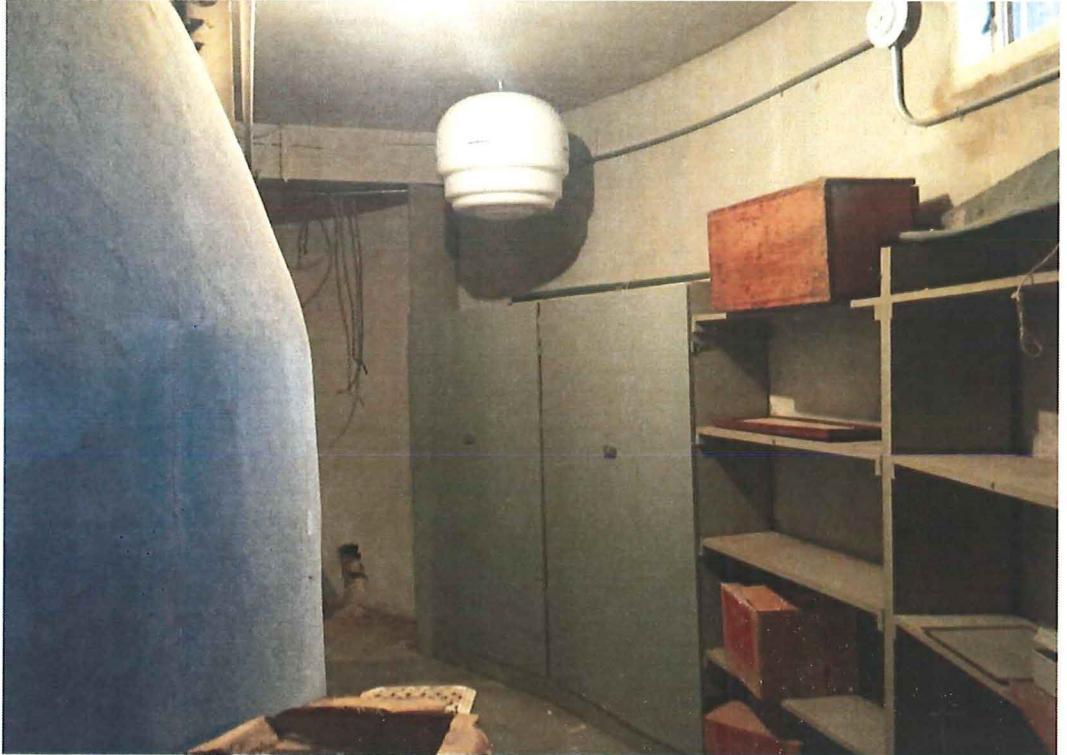
EXAMPLE OF THE LARGEST RENODRY TAKEN AT THE OLDEST OBSERVATORY IN MINNESOTA. LOCATION: NORTHFIELD
